## An Old Door Gets a Second Chance

Schlepping and restoring a 20-ton vintage vault door

A safe and vault technician schleps a 20-ton vintage vault door from a defunct bank in Chicago, restores it in St. Louis, and returns it to its new home in Chicago. In the process, he preserves rich, Great Depression-era history.

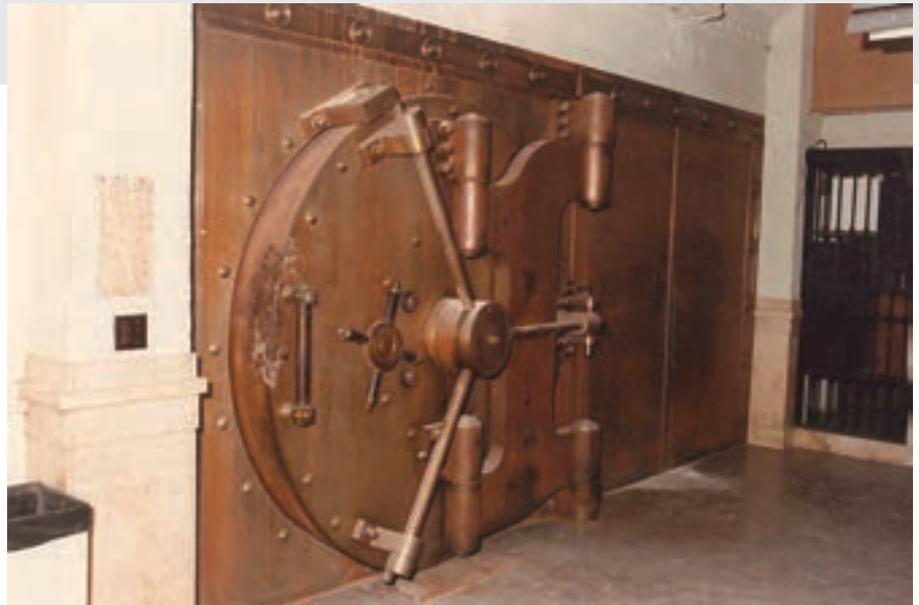
**Figure 2.** This 20-ton vault door was covered in rust after five and a half decades of sitting idly in the old bank, which, at the time of the restoration, was being used as a school for homebuilders.

Inspection of the door revealed a lot of restoration challenges. The first thing I noticed, of course, was the heavy rust overall. A closer look revealed an interesting ½-inch wide groove from rust that came from a leak in the roof directly above the clock. The water had run down from the clock, over the front of the top architrave, over the front of the frame, down through the opening and

around the jamb to the bottom. The rust trail ran back out and down the lower face of the frame.

Too bad they had not kept the door closed, I thought. After all, these doors were built specifically to keep out liquids, although nitroglycerin was the liquid of most concern. The door must have been open and the roof must have leaked most of those many years. The pitting from the stream was at least 10-thousandths of an inch (0.010 inch) deep.

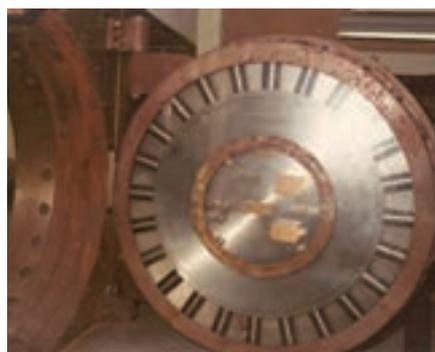
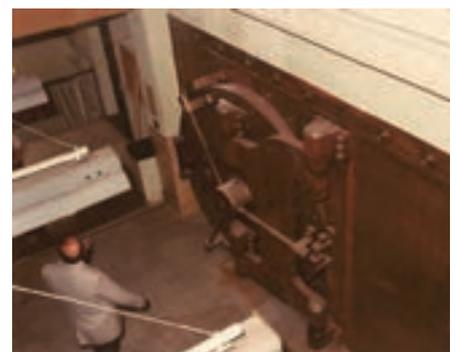
**Figures 4 and 5.** The door, which, again, was covered in rust, faced the bank's lobby. The job was to remove the door from the building in Chicago; take it to the shop in St. Louis for restoration; and re-install it in a new bank.

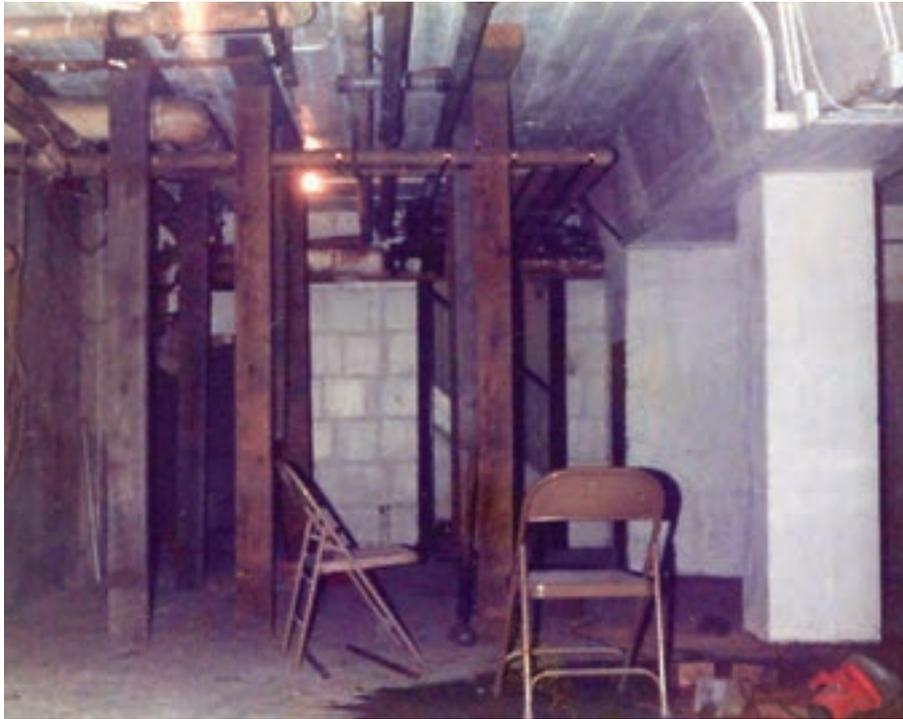
**Figure 6.** Under the lobby where the vault door was located was a basement, which had to be reinforced before the door could be moved.

The lobby, the only way out of the building with the door, was at least 50 feet long from the vault to the exit door. There was basement space the entire distance (*Figure 6*). (Sorry about photo quality, Folks. We forget in this digital age that Polaroid was about convenience, not quality.) I took a note specifically reminding me to bring enough wood to brace the floor after seeing this.

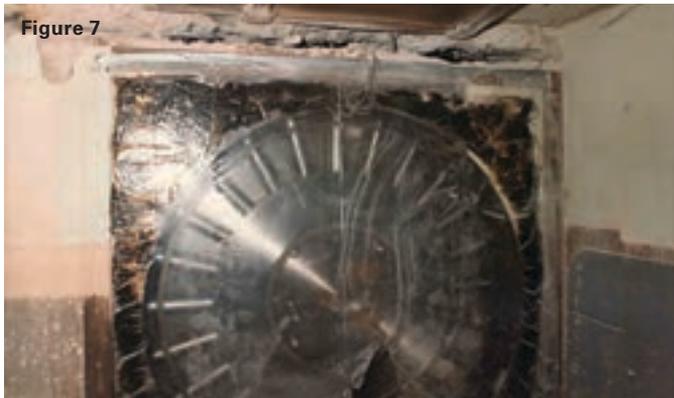
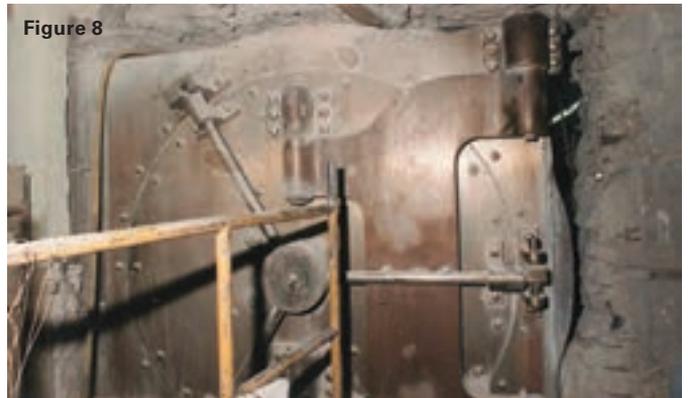
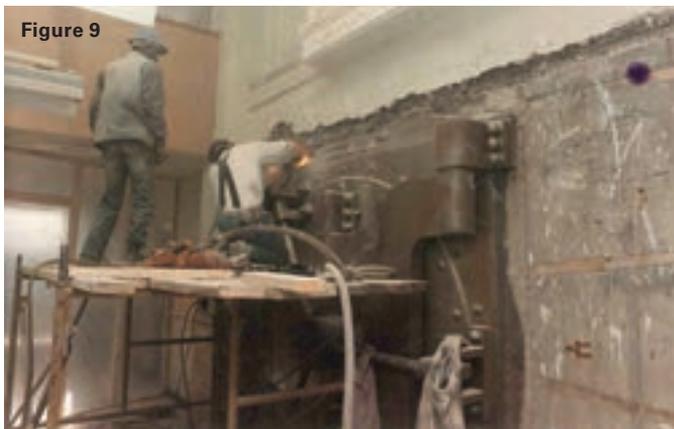
**Figures 7-9.** It took the crew seven days of taking turns with the jackhammer and the torch to cut through the wall. This was done through a cloud of thick dust and smoke. It was hard to breathe or see, even though fans were running all day to move the air outside.

nothing but noise, dust and torch fire. As the concrete broke away, a mesh of reinforcement rod was revealed: 1-inch rebar was set every 4 inches, both vertically and horizontally throughout the 24-inch thick walls. We traded off turns at the jackhammer and the torch for the next seven days through thick dust and smoke. It was hard to breathe or see, even though we had fans running all day to move the air outside (Figure 7-9).

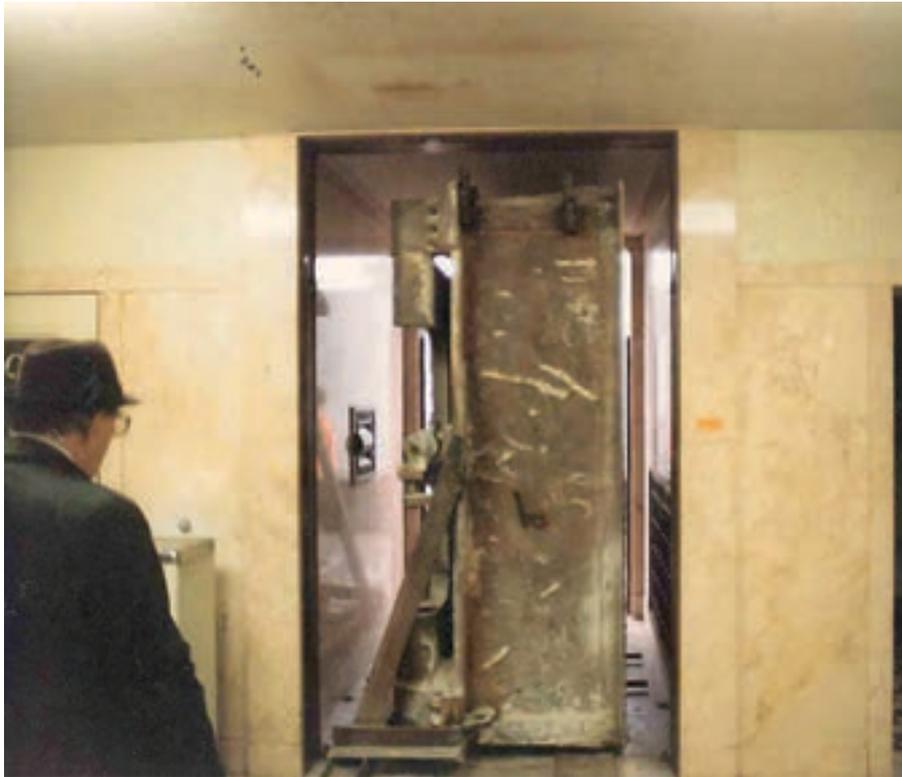
**Figure 13.** When the door was originally measured for height, it was before the frame had been fully exposed. Upon re-measurement, the center was noticeably taller.

It dawned on me that when we measured the door for height, it was before the frame had been fully exposed. Upon re-measurement, the center was noticeably taller (*Figure 13*). The exit doors were already taken off, but now the frame had to come out too. That took some extra time, but everyone was focused on the lift outside (*Figures 14-15*). We would have to close the southbound lanes of Cicero in front of the building for the crane to park. From there we would lift the door onto the flatbed trailer bound for St. Louis (*Figures 16 and 17*).

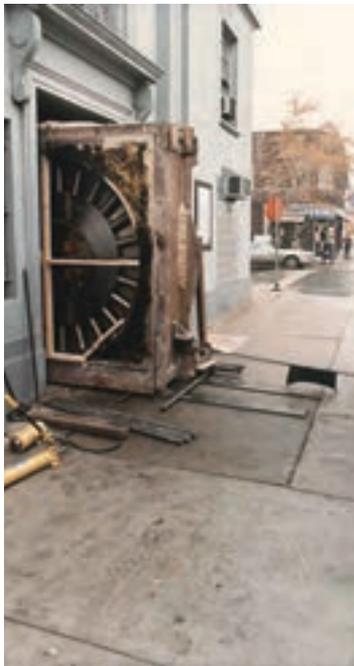
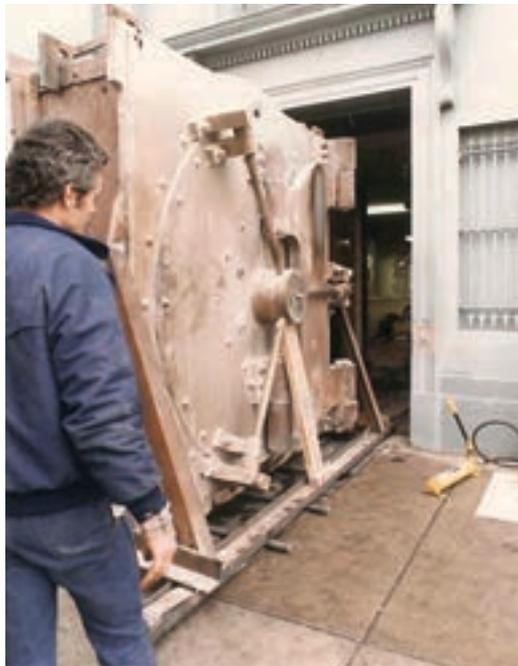
**Figures 14-15.** The exit doors were already taken off, but now the frame had to come out too. That took some extra time, but everyone was focused on the lift outside.

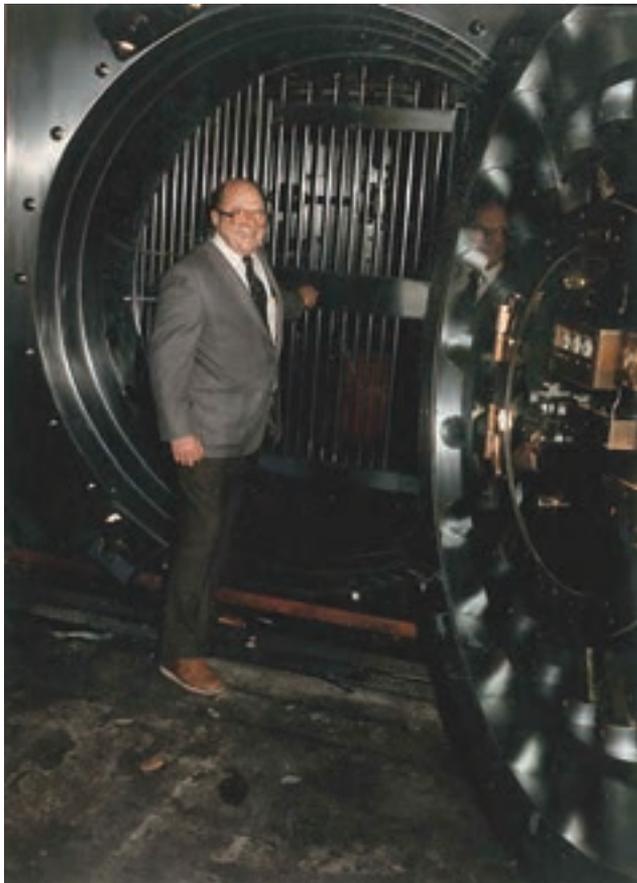
**Figure 21.** Harvey Cleven, the door's owner, took a look at it before it was installed in its new home, Chicago's Community Savings Bank, where he served as president.

Within a year, everything was finally assembled, tested, shimmed and re-tested (*Figure 21*). I made and supplied new installation drawings to the builder of the new bank and vault to show the required masonry opening. A new aluminum foot-bridge was made to ease passage into the vault over the threshold. Everything that could possibly rattle loose on the truck ride to the new location had to be removed and crated separately (*Figure 22*).
