## An Old Door Gets a Second Chance

Schlepping and restoring a 20-ton vintage vault door

A safe and vault technician schleps a 20-ton vintage vault door from a defunct bank in Chicago, restores it in St. Louis, and returns it to its new home in Chicago. In the process, he preserves rich, Great Depression-era history.

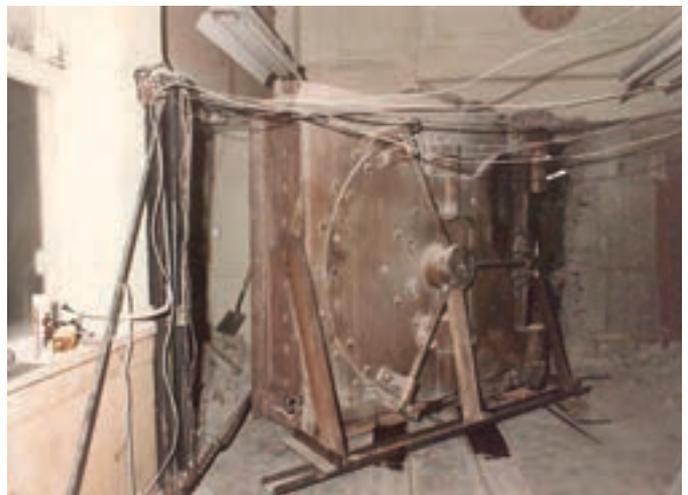
**Figure 10.** Eventually, the door appeared to be free of the wall.

Eventually, the door appeared to be free of the wall (Figure 10). I welded jacking lugs to the side of the frame and got out the new 10-ton hydraulic bottle jack, which was purchased just for this job. A few tries and angles were tested, and soon the frame broke free from the concrete with a bang. The lift continued until skid plates could be fit under the frame, parallel to the hallway, and toward the exit. We worked the turntable under the center and set the door down on it.

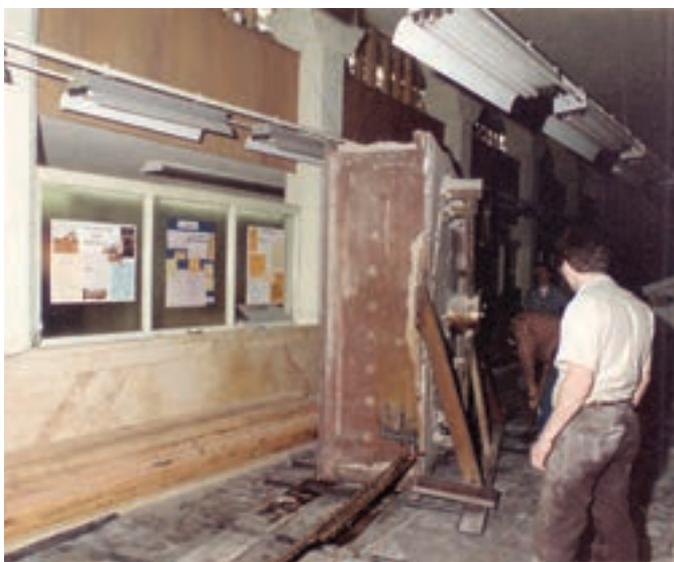
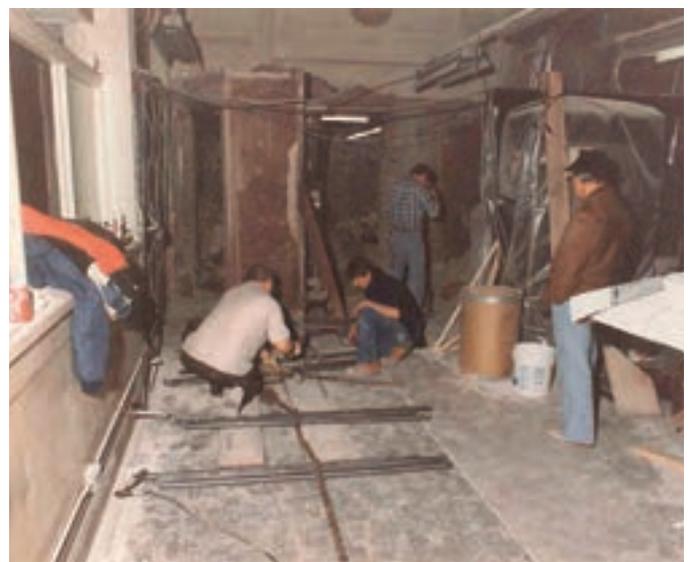
**Figures 11 and 12.** We kept 1-inch-diameter rollers in close groups of three about three feet apart. Except for the occasional binding, the hallway stretch went well.

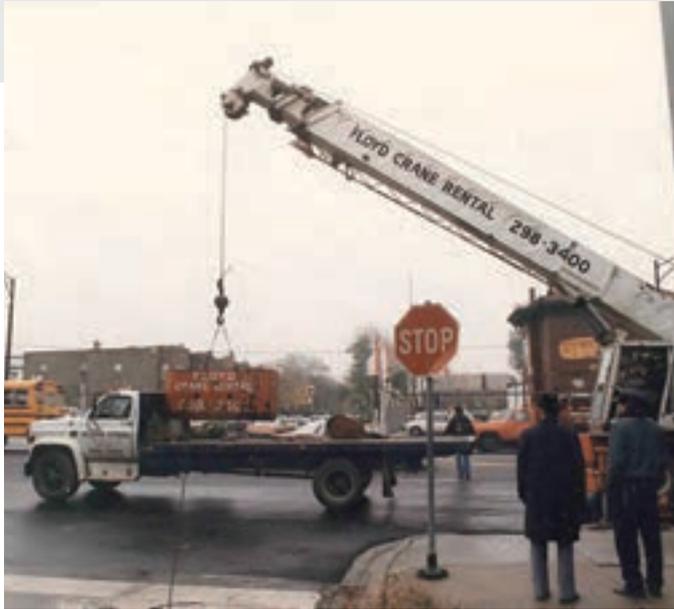
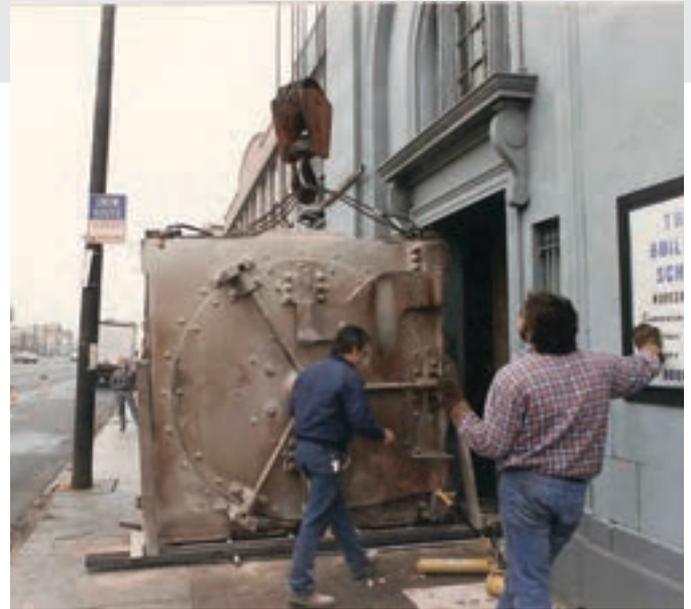
**Figures 16 and 17.** The crew had to close the southbound lanes of Cicero in front of the building for the crane to park.

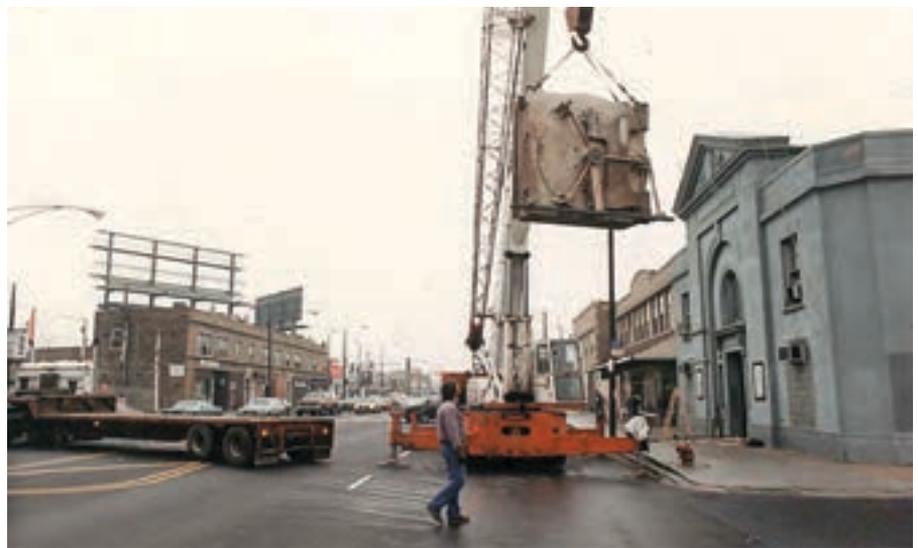
Telephone lines went parallel to the street on our side, right along the curb. The plan was to roll the door out just far enough to clear the building, then lift it and turn it between the lines and the building before raising it. That lift had to be 30 feet or so to pass over the lines with the door (*Figure 18*).

**Figure 18.** The crane had to lift the vault door about 30 feet in order to clear the telephone lines.

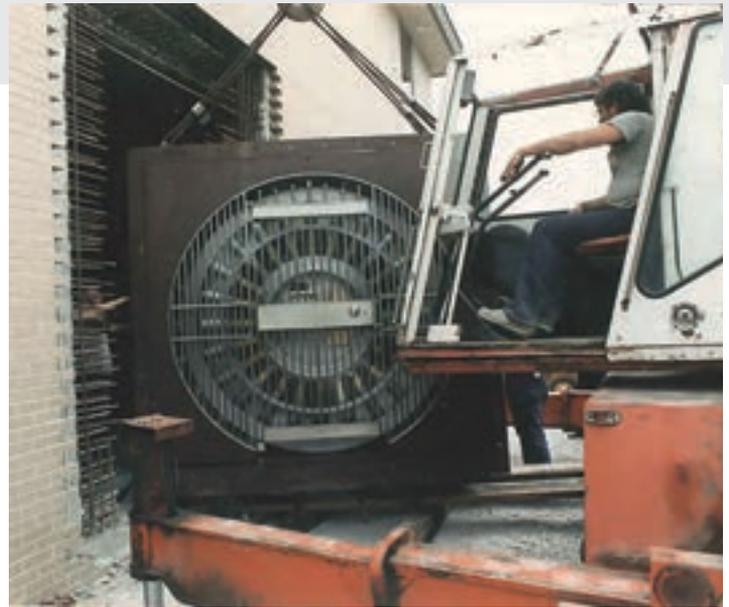
**Figure 22.** Everything that could possibly rattle loose on the truck ride to the new location had to be removed and crated separately.

Within a year, everything was finally assembled, tested, shimmed and re-tested (*Figure 21*). I made and supplied new installation drawings to the builder of the new bank and vault to show the required masonry opening. A new aluminum foot-bridge was made to ease passage into the vault over the threshold. Everything that could possibly rattle loose on the truck ride to the new location had to be removed and crated separately (*Figure 22*).
